# Manhole Inspection Summary

Manhole # S31S1\_002MH

Insp Date: **2/15/08 9:10 AM**

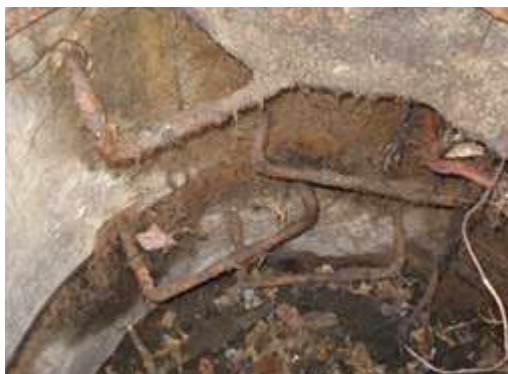
Steps

**Steps** Count: **5** Missing: **0** ☐ Corroded

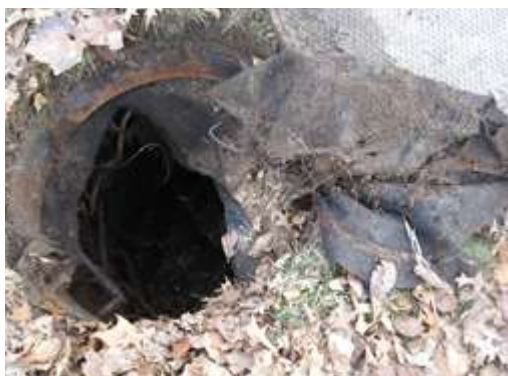
Defect 1

Condition: ☐ Sound ☐ Cracked ☐ Root Intrusion ☐ Deteriorated ☐ Leaks ☒ **Debris**

Channel

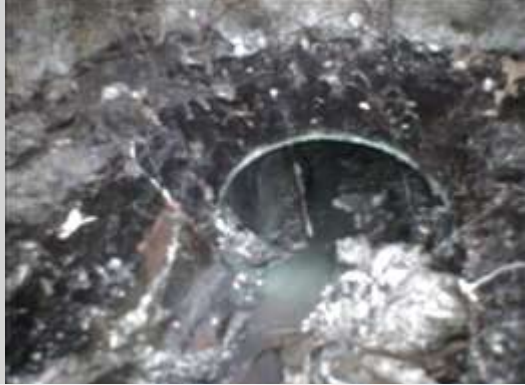
12 O'Clock Outflow

8 in. Circular Gravity Sewer  
Pipe Out @ 12 O'Clock

Pipe Height: **8.4** (in.) Rod and Bar (Angled)  
Pipe Material: **PVC** ☐ Pipe Lined  
Invert Depth: **6.51** (ft.) Flow Characteristics: **Fast**  
Deposits: ☒ None ☐ Mud ☐ Sludge ☐ Debris ☐ Grease  
Silt Depth: (in.) Deposits Extent:  
Infiltration: **None** Pipe Seal Cond: **Sound**

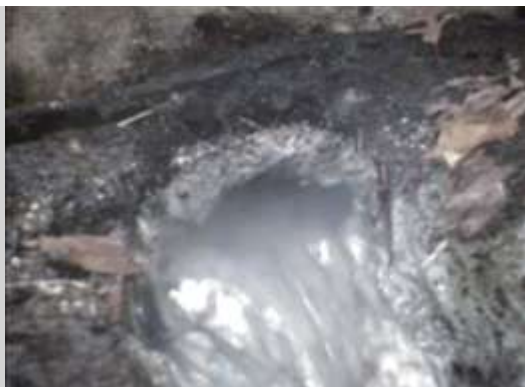
6 O'Clock Inflow

8 in. Circular Gravity Sewer  
Pipe In @ 6 O'Clock

Pipe Height: **8.4** (in.) Rod and Bar (Angled)  
Pipe Material: **PVC** ☐ Pipe Lined  
Invert Depth: **6.76** (ft.) Flow Characteristics: **Fast**  
Deposits: ☒ None ☐ Mud ☐ Sludge ☐ Debris ☐ Grease  
Silt Depth: (in.) Deposits Extent:  
Infiltration: **None** Pipe Seal Cond: **Sound**
